Smoke and Dye Testing Summary

High Level Sewershed

Test ID	Test Type	Date Inspected	Company / Super.	Blower MH	Ground Condition	Notification Made?	Total Length
S1028-175	Smoke	7/20/2009	ADS/TM	S13AA_066MH	Dry	Yes	660.95

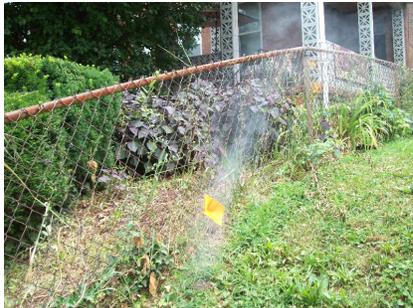
Picture \S1028-175-OB01-P01.jpg

Comments Smoke from cleanout (missing cap) in front yard. 2805 Mosher St.

Comments Front of house, 2805 Mosher St.

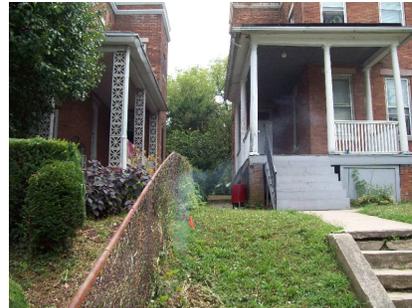
Picture \S1028-175-OB01-P02.jpg

Comments Front of house (location view), 2805 Mosher St.

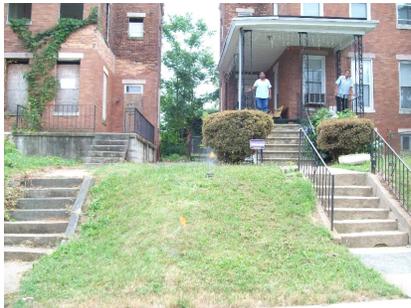
Picture \S1028-175-OB02-P01.jpg

Comments Smoke from cleanout (broken cap) in front yard. 2813 Mosher St.

Comments Front of house (flag in background), 2813 Mosher St.

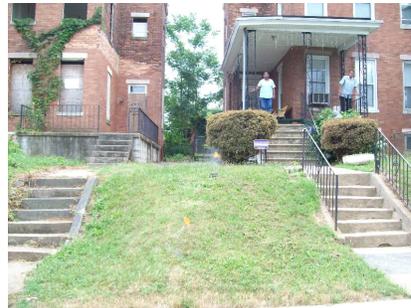
Picture \S1028-175-OB03-P01.jpg

Comments Smoke from cleanout (missing cap) in front yard. 2811 Mosher St.

Comments Front of house (flag in foreground), 2811 Mosher St.

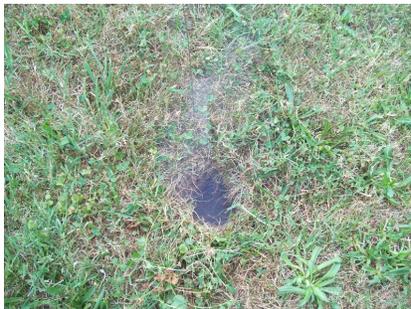
Picture \S1028-175-OB03-P02.jpg

Comments Smoke from cleanout (missing cap) in front yard. 2811 Mosher St.

Comments Front yard, 2811 Mosher St.

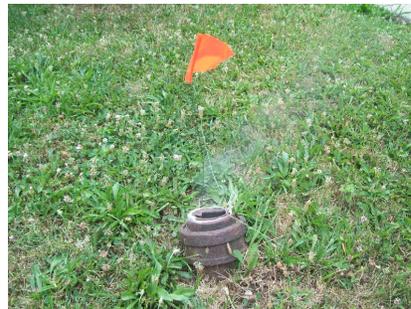
Picture \S1028-175-OB04-P01.jpg

Comments Smoke from above-grade cleanout (broken cap) in side yard. 931 Poplar Grove St.

Comments Side yard, 931 Poplar Grove St.

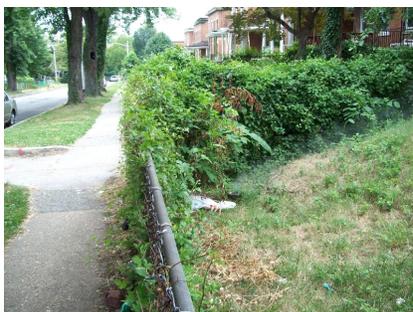
Picture \S1028-175-OB05-P01.jpg

Comments Smoke from cleanout (missing cap) in side yard of 2823 Mosher St.

Comments Side yard, 2823 Mosher St.

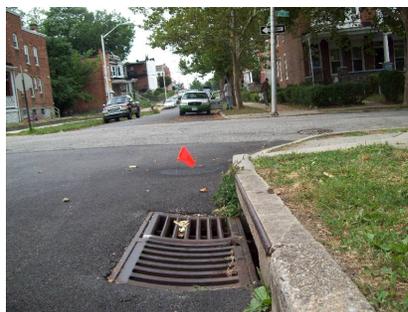
Picture \S1028-175-OB06-P01.jpg

Comments Smoke from catch basin along curb on southeast corner of Mosher St. & Dukeland St.

Comments Mosher St. & Dukeland St. looking north
